## Service Performed For:

Date Opened: 8/25/2004

Inspection Date: 7/13/2021

## Summary of Issues

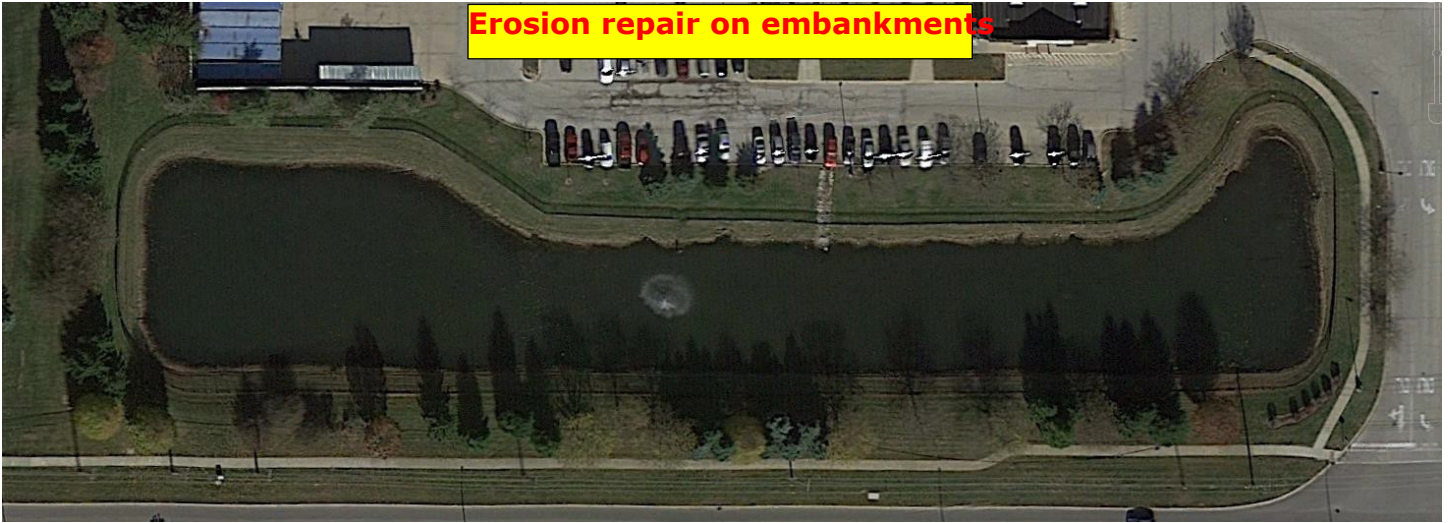
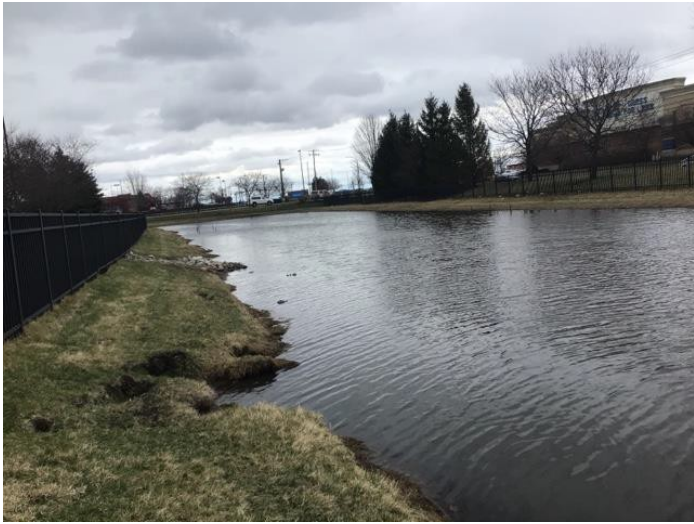
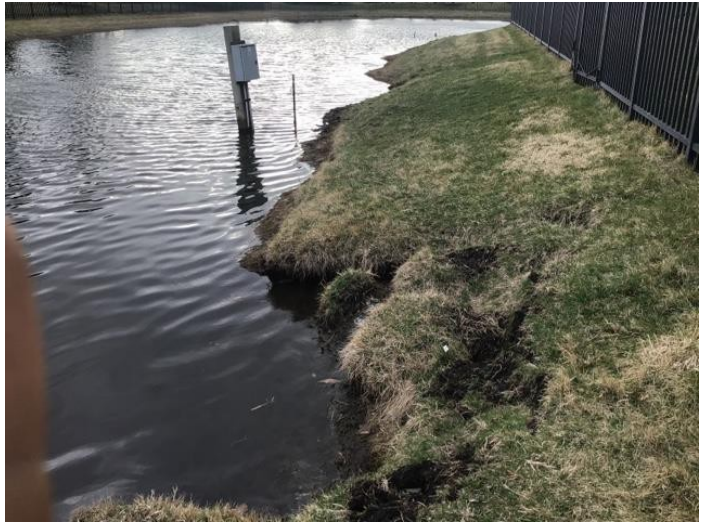
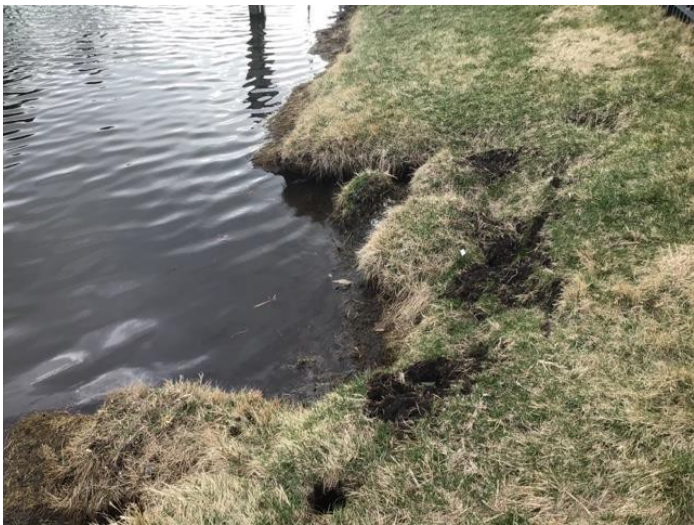
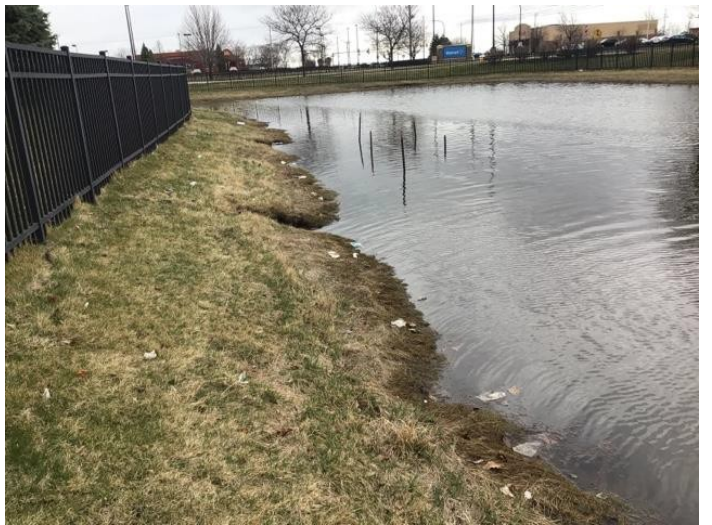
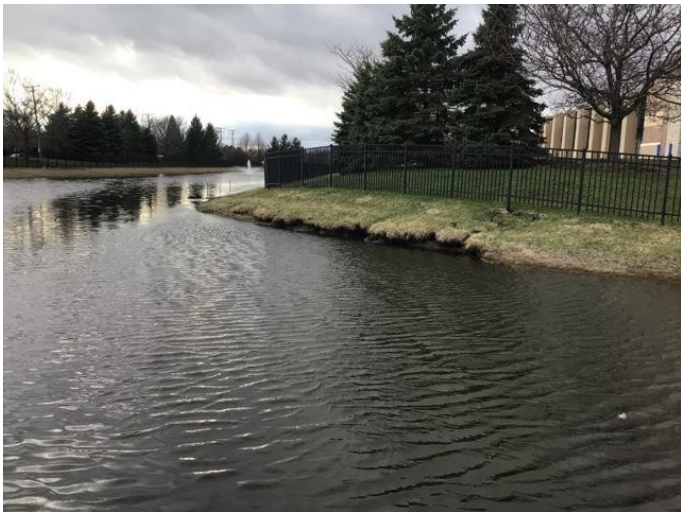
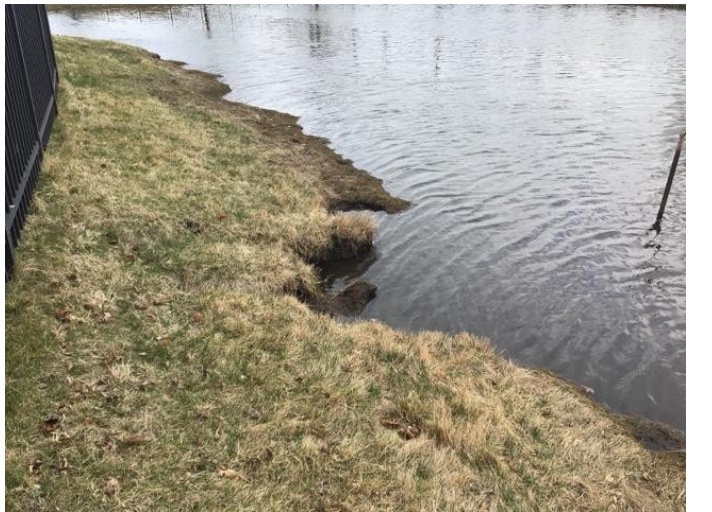
## Retention Basin A- Erosion Repair

There are two retention basins on the south side of the facility that are experiencing moderate to severe erosion on their embankments.

Pests; wave action caused by fountains

*Function/Safety; repair erosion on basin embankments to ensure safety of maintenance crews; repair damaged fountain breaker*

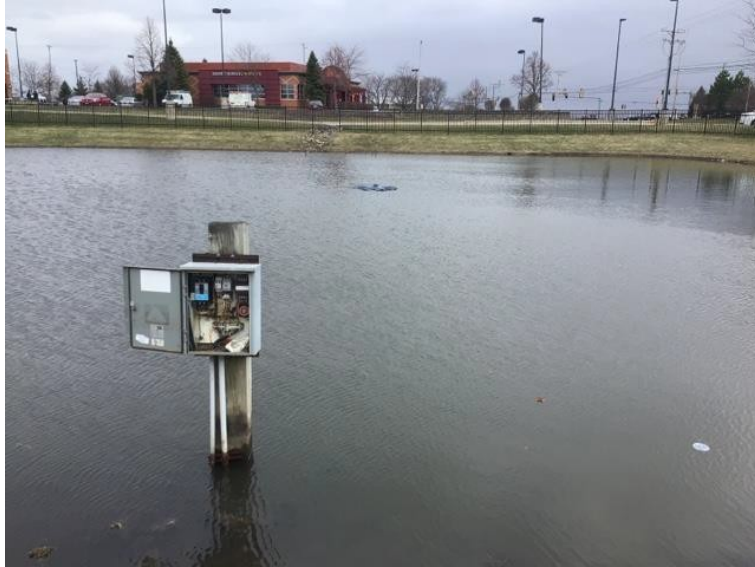
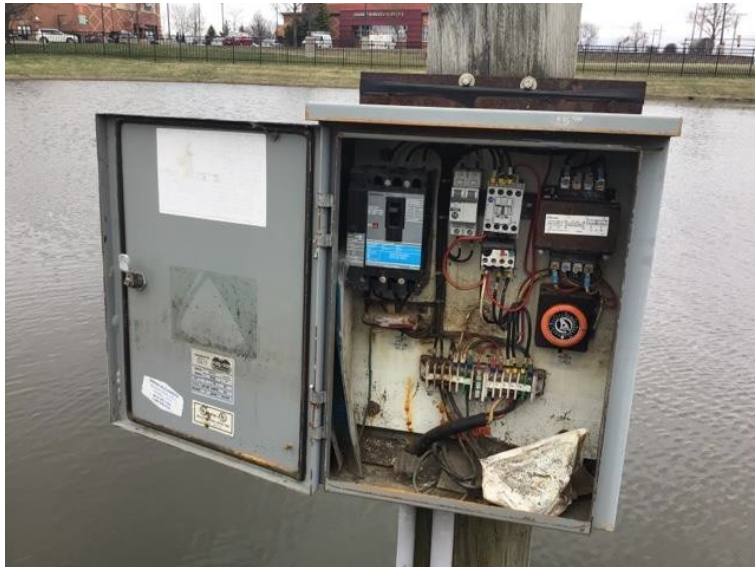
## Retention Basin B- Fountain Repair

The fountain panel in Retention Basin B is inoperable and needs to be replaced.
